Fact Sheet

Mishandling of PCBs: A Case Study

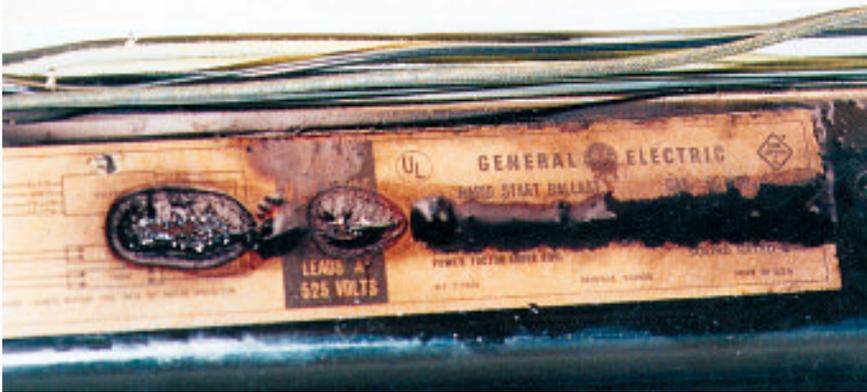
Light fixture with leaking ballast

In June 1999, the U.S. Environmental Protection Agency (EPA) received a complaint about a leaking fluorescent light at the Wilsonville Primary School in Oregon. A sample of the oily substance that dripped from the fixture was tested by a lab. It contained PCBs, which was reported to the principal and the district's maintenance staff.

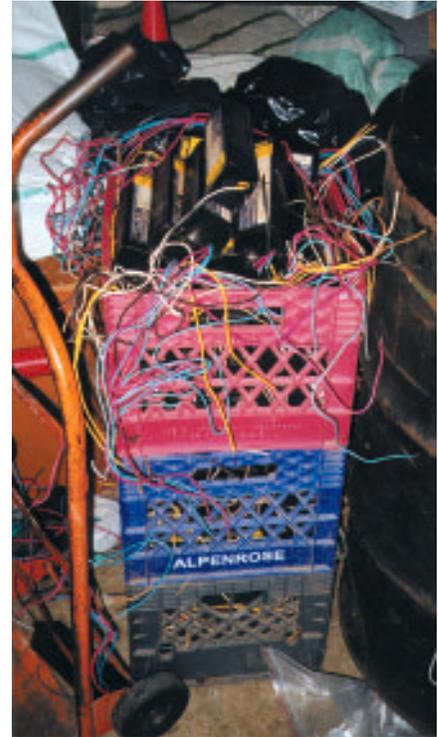
EPA inspected Stafford Primary School and discovered that the old fixtures were not being properly handled. Leaking PCB ballasts were being stored on the school playground. Workers handling the leaking PCBs ballasts were not trained in the proper handling of hazardous materials.

Ballasts were removed from light fixtures and stored in open bins

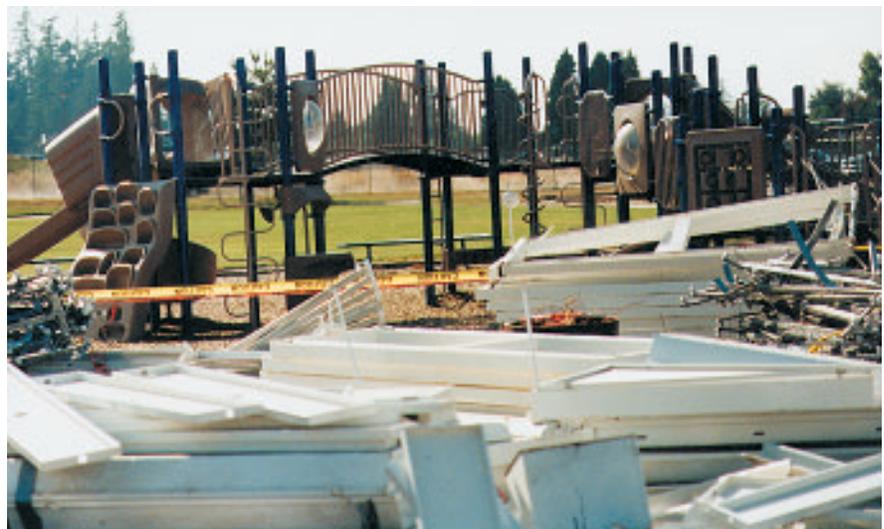
Fixtures and leaking ballasts were stored on playground

EPA and school district staff met in August to discuss what needed to be done to fix the problems and make sure that PCBs were not being spread around. By the end

of August, the school district had cleaned up the PCBs. However, the school district is still facing financial penalties sought by EPA for alleged violations of the federal PCB regulations.
